AGENDA

Infrastructure and Regulatory Committee Meeting

10 September 2024

W02610500 – MAHANGA WETLAND HYDROLOGICAL ASSESSMENT

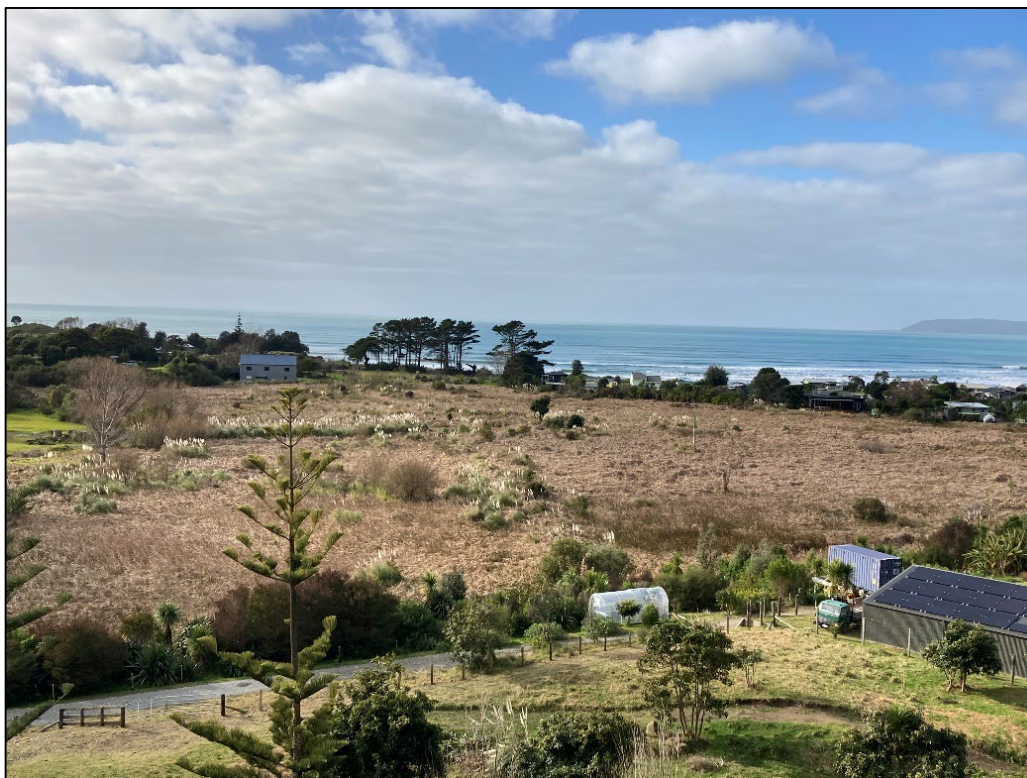
Photograph A1: View east over the Mahanga Wetland. The wetland is filled with raupō, with pampas growing along raised bunds.

The dominant vegetation in the wetland is raupō, which typically grows in large colonies, in shallow, fresh, or slightly brackish water (Maanaki Whenua, n.d.). The wetland has an uneven surface, and it has been anecdotally observed that lower lying zones have permanent water while higher zones are ephemeral. A review of recent aerial imagery and observations made during the site visit suggest that the majority of the wetland is covered with raupō and there are few areas of open water (Photograph A1).

The channel is culverted under Mahanga Road, flows in a southerly direction before abruptly turning to the southeast. The channel bisects the wetland in a straight line before becoming the Hine Rauiri Stream at the eastern covenant boundary. Further drainage, a causeway and other raised bunds were installed many years later. The specific dates are unknown but based on available aerial imagery, modifications appear to have occurred between the 1980's to early 2000's (Retrolens and Google Earth). Pampas has been observed growing along the raised areas, which may indicate different hydrological conditions i.e., a greater depth to groundwater (Photograph A1).

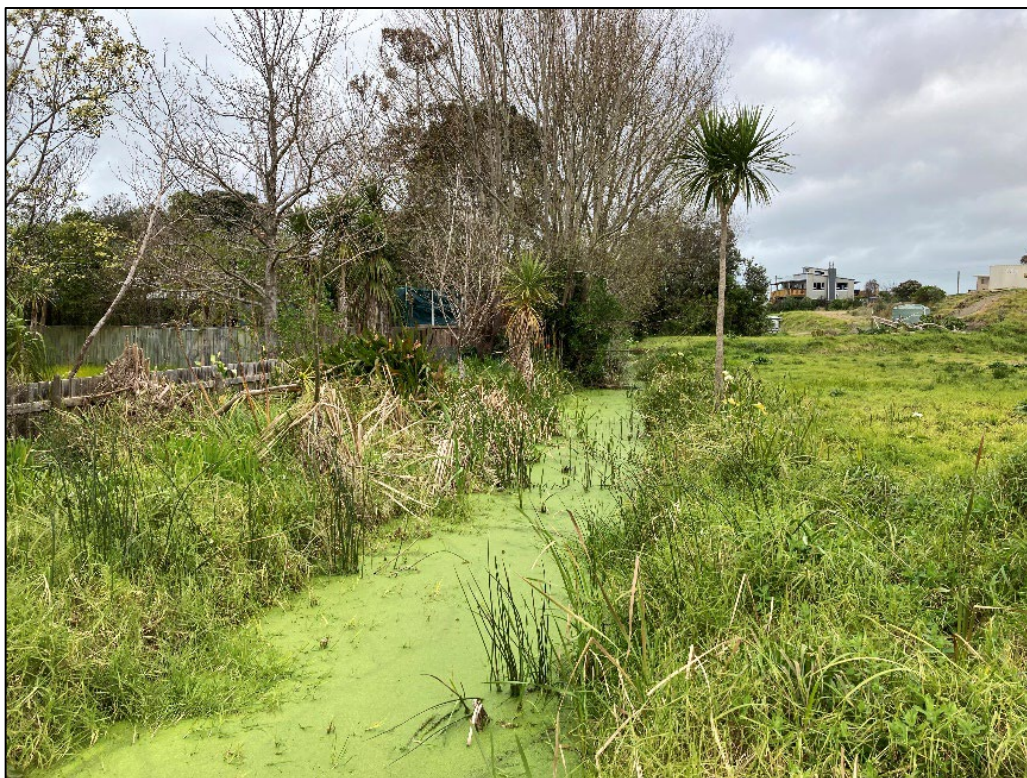
Photograph A3: Duckweed growth within the stormwater drain behind 6-7 Quentin Place. The water level is only slightly lower than the ground level.

During the site visit, the stormwater drain was observed to have a high water level which was very close to ground level (Photograph A3). Very minimal to no flow was observed and substantial duckweed (*Lemna disperma*) had established in parts of the channel. Duckweed grows in wetland environments, ponds and shallow streams where the current is slow-moving (de Lange, 2023). This indicates that these conditions are typical of the stormwater drain. In other areas, the stormwater drain was choked with raupō (Photograph A4). Anecdotal reports indicate that localised areas of the drain may also be partially clogged with rubbish and/or garden waste.

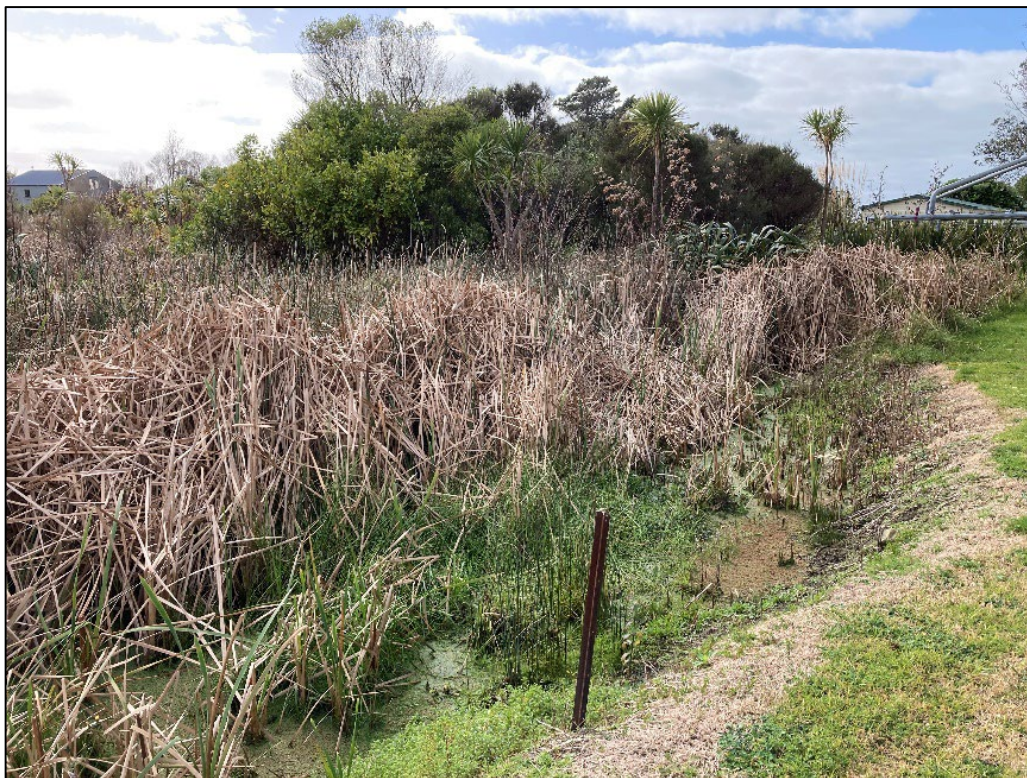
Photograph A4: Raupō growth within the stormwater drain at 6 Rhona Place. The water level is only slightly lower than the ground level.

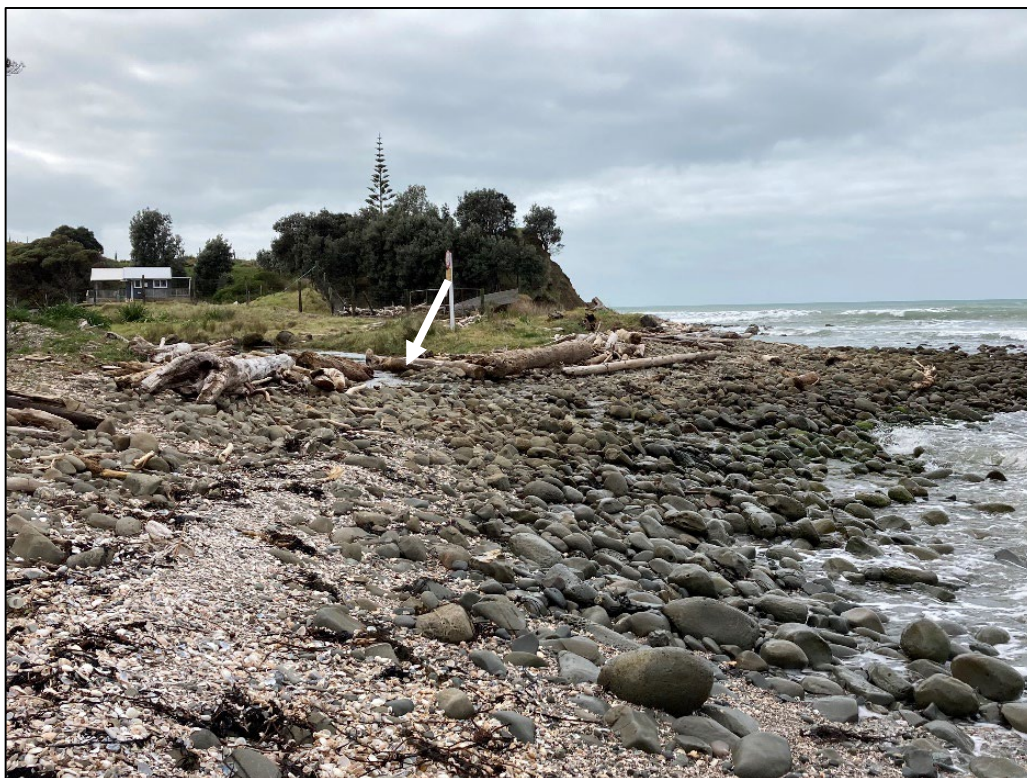
Photograph A5: Mouth of Hine Rauiri Stream (white arrow). The majority of elevation in the stream is lost at the beach front.

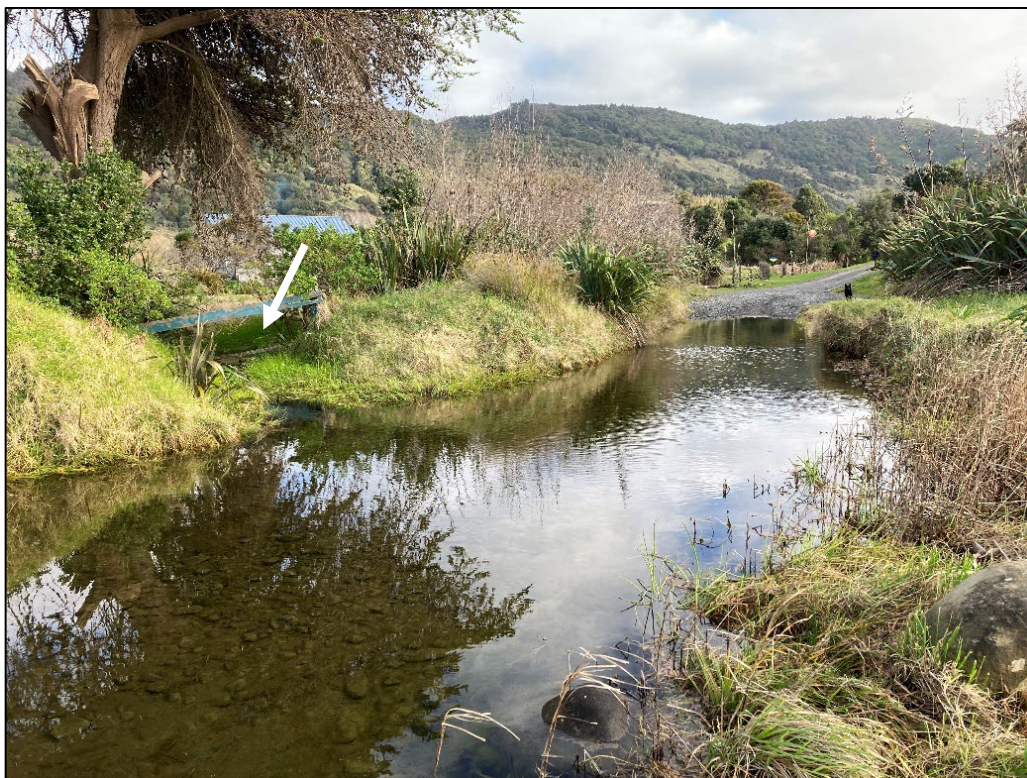
Photograph A7: Happy Jacks Road Ford. Hine Rauiri Stream enters ford at arrow.

The Happy Jacks Road ford currently acts as part of the stream bed, but the depth of the stream is considerably shallower and is likely to be above the groundwater table at this location. The issues arising from the ford becoming flooded and unusable are governed by the invert levels of both the ford and the stream mouth. The level of the ford is likely to have degraded over time as a result of use, while the level of the stream mouth fluctuates in response to the coastal environment and flow conditions within the stream.

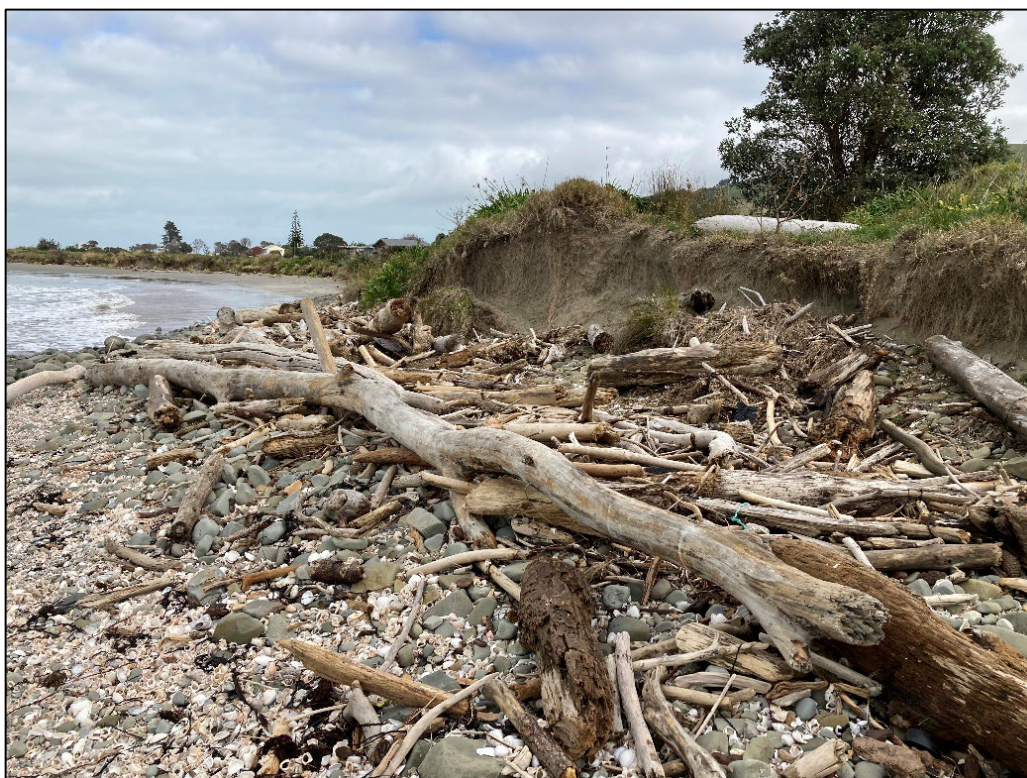
Photograph A8: Coastal erosion and debris washed up on shore near the mouth of Hine Rauiri Stream.

The mouth of the stream is located in a small embayment. Due to the dynamic nature of the coastal environment, the mouth is periodically choked with debris thrown up by the ocean including sand, cobbles/boulders and wood debris. Local residents and council staff have removed this material and debris to 'unblock' the stream. Wave action also causes erosion along the coastal dunes (Photograph A8).

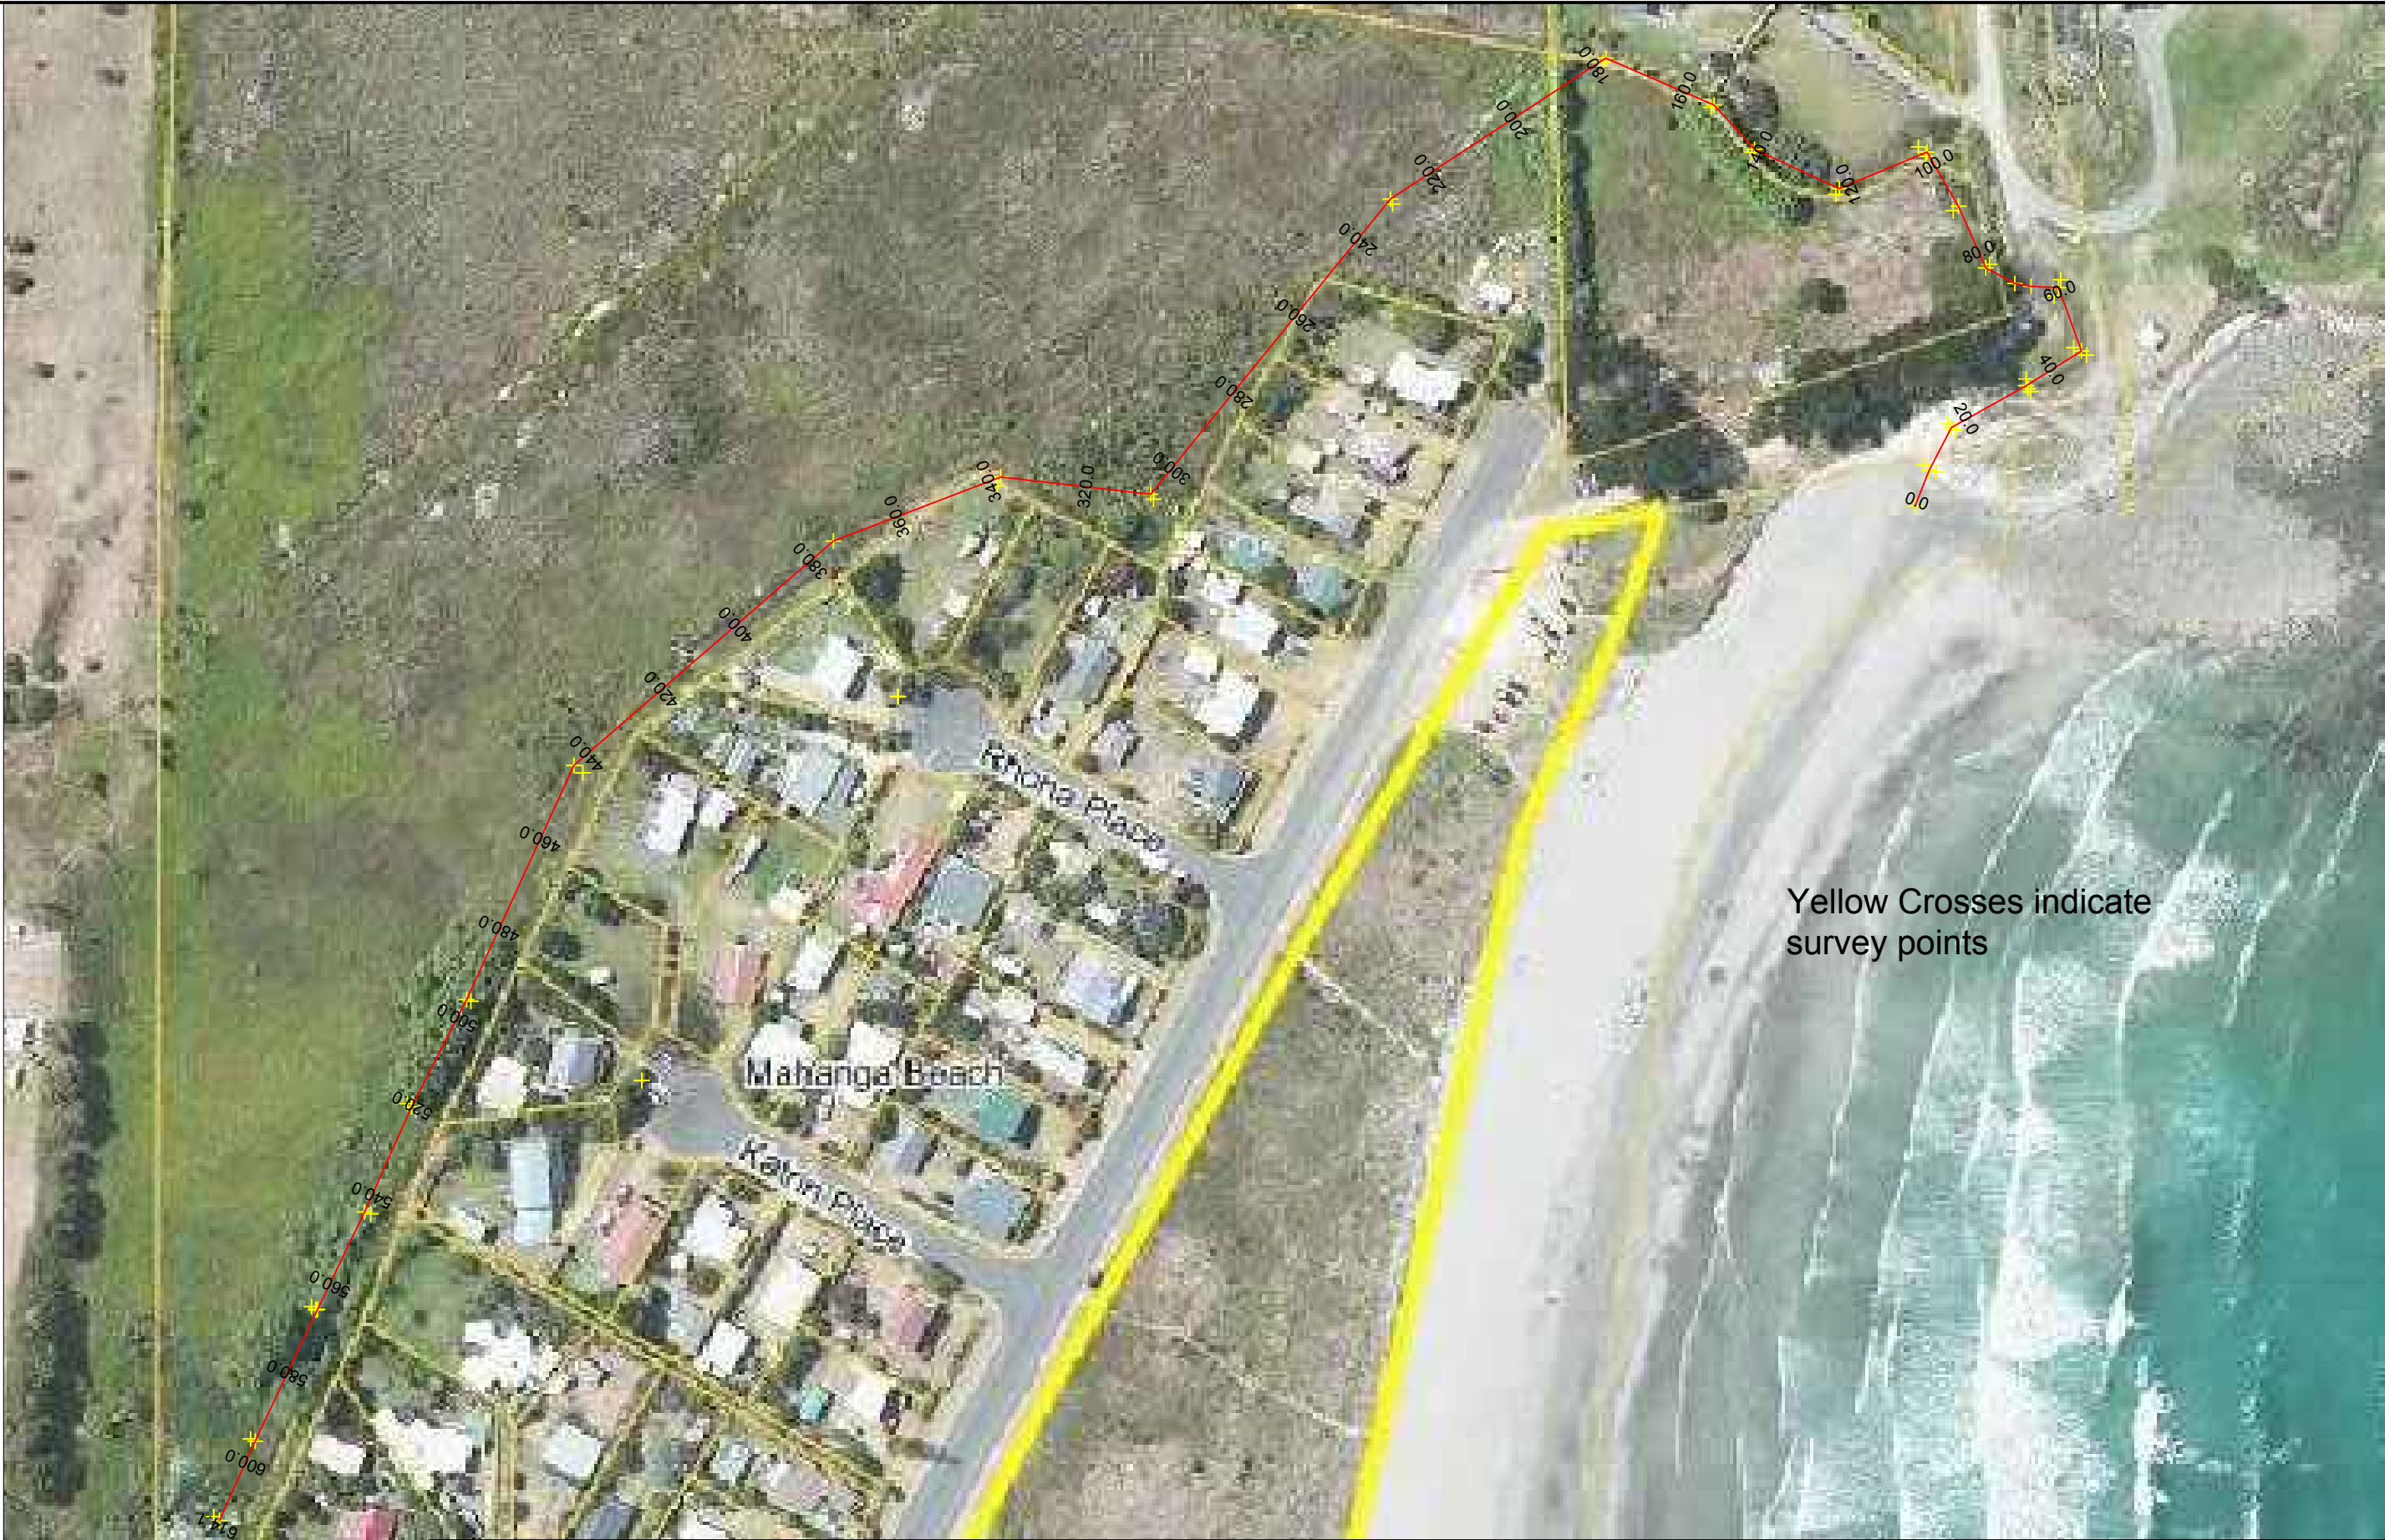
Title Mahanga Drain Survey			
		Drawn	AJH			Contract			
		Checked				Scale N.T.S			
		Approved				Date Jun 18	Job No.	Sheet 01	Re
Amendments		Date

Yellow Crosses indicate
survey points

As noted above, the Hine Rauriri Stream conveys water from the wetland, including the discharge from the Tamatea Spring. Based on the 2017 survey (Appendix B), the base of the Hine Rauiri stream between the wetland boundary and the ford is well below groundwater level (resulting in groundwater inflow).

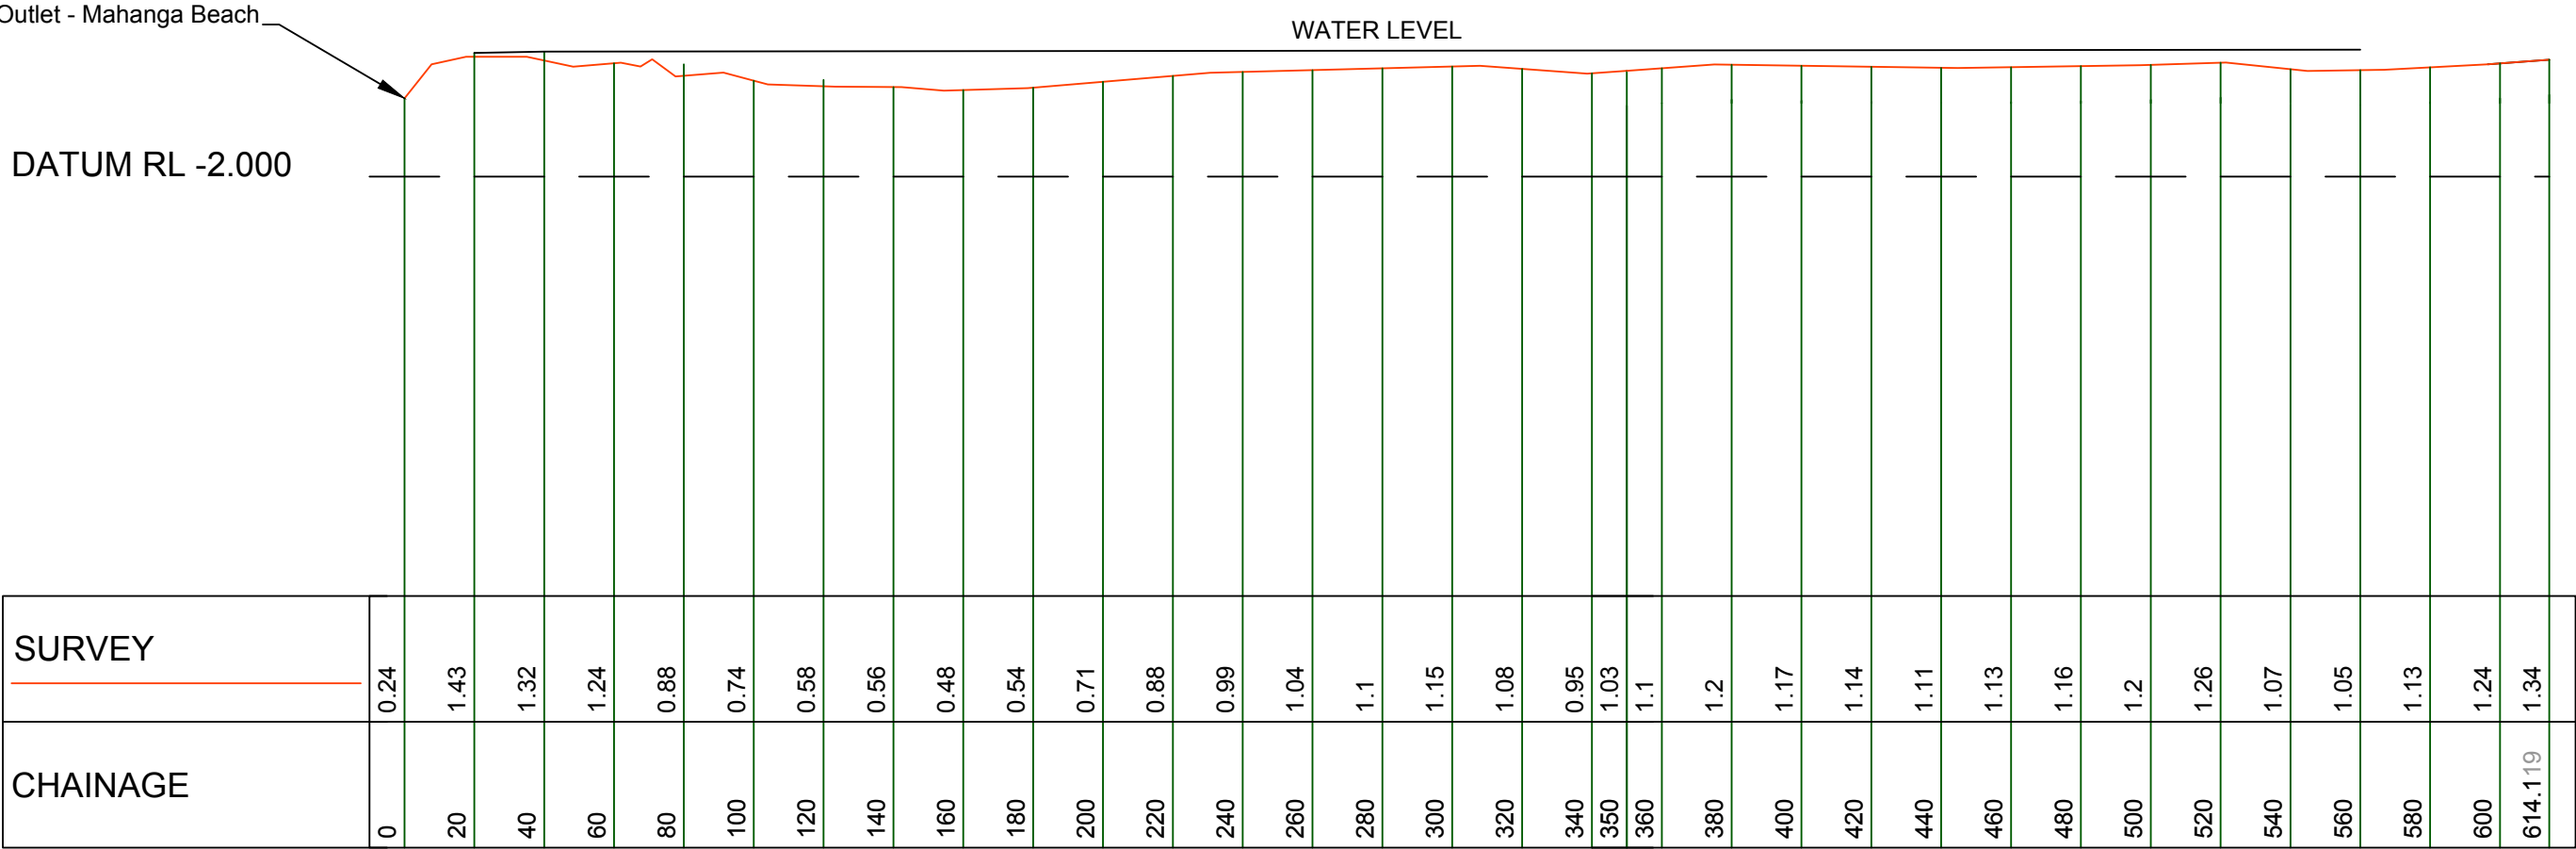
- LONGITUDINAL SECTION
A1 HORZ SCALE 1:2000
A1 VERT SCALE 1:200

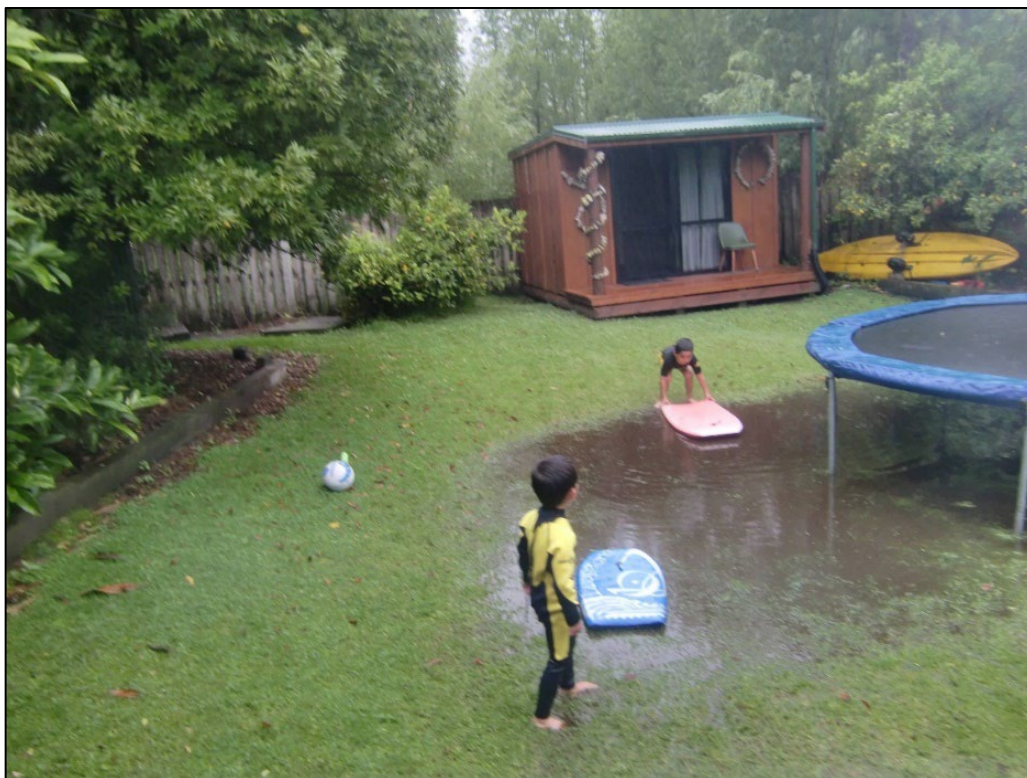
Photograph C1: Flooding (1 August 2012) at 5 Quentin Place.

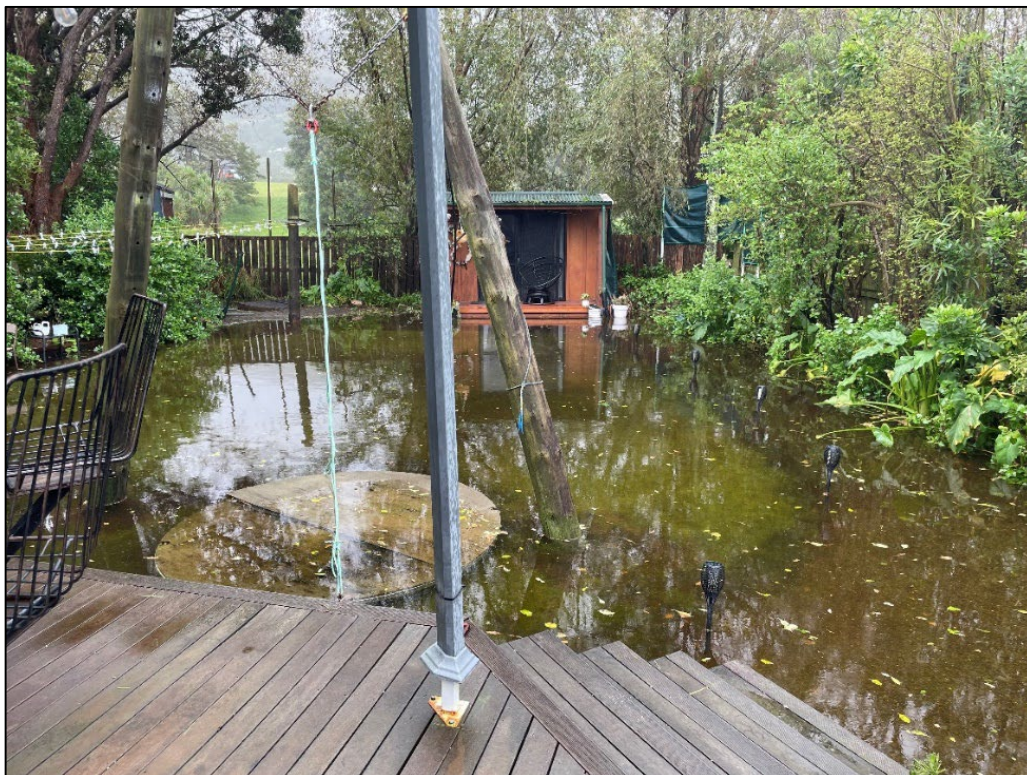
Photograph C2: Flooding during Cyclone Gabrielle (14 February 2023) at 5 Quentin Place.
